Journal of Rehabilitation in Civil Engineering

# Historical and Structural Analysis of the Lintel Fracture Over the Monastery of El Escorial Main Door

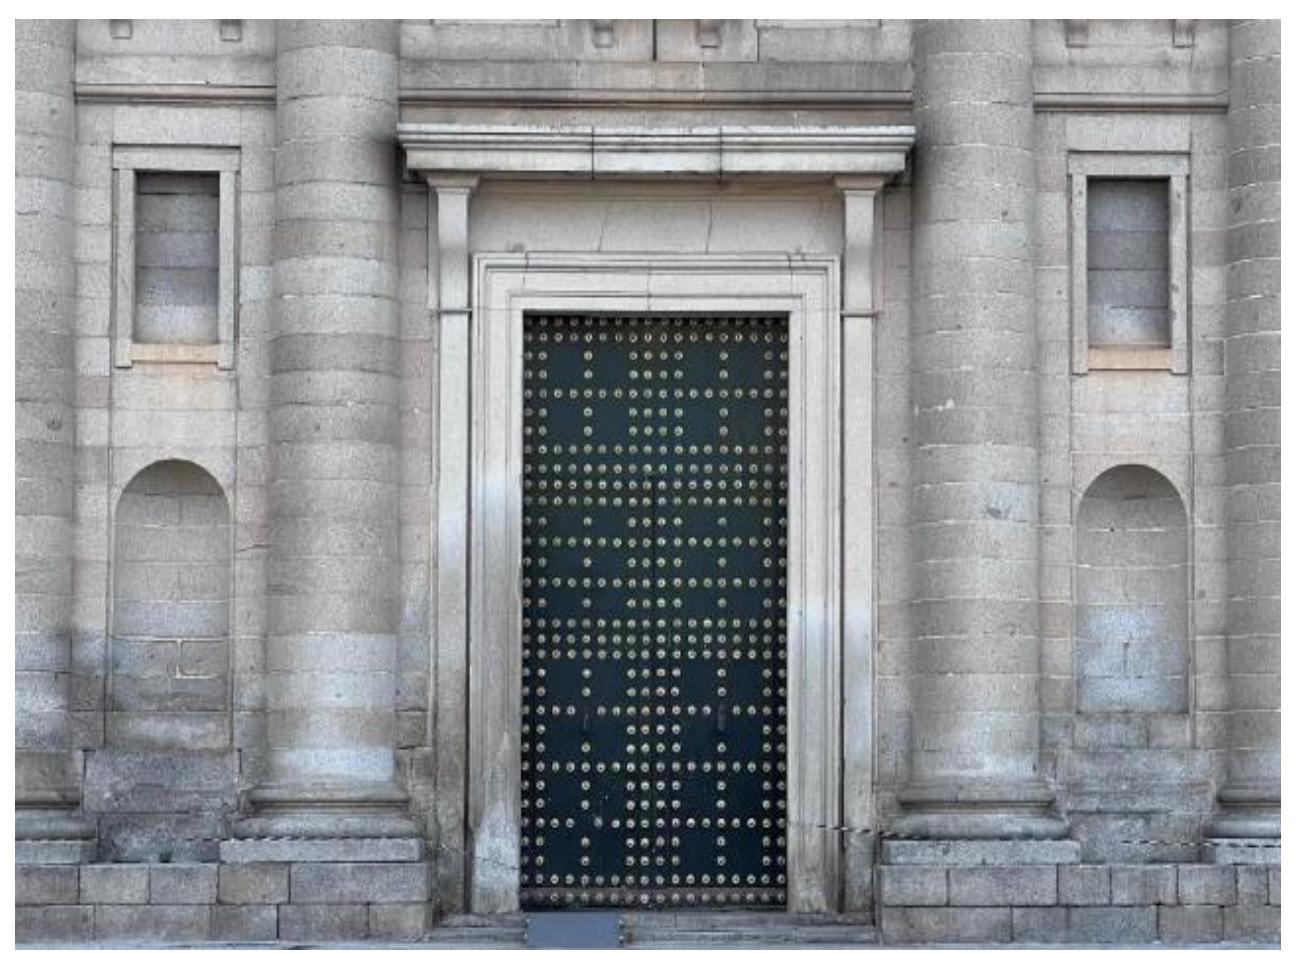
Fig. 3. Principal entrance to the Monastery of El Escorial on its western facade, where the lintel discussed in this article is situated (photograph by the author).

This single-span entrance is possible thanks to two one-piece lintels, arranged one above the other, with a small cornice above them (Fig. 3). We do not need to get very close to notice striking fractures in these two elements. Here we are going to try to explain these fractures and assess whether they present any cause for concern.

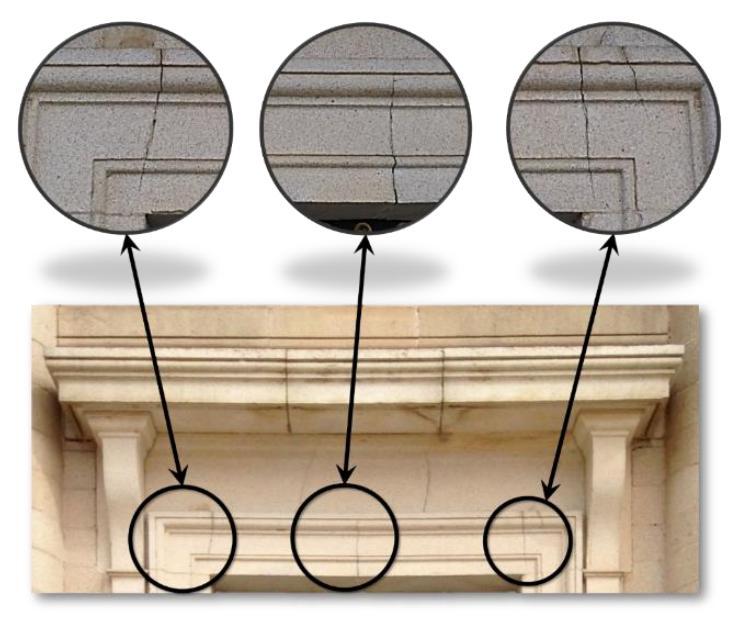
With the photographic material obtained in both inspections, we made up an exhaustive photographic report. This report allowed us to conduct a very detailed lesion mapping (Fig. 8 and Fig. 9). We were not only able to locate and analyze all the fractures produced in the lintel, but also verify that attempts had already been made to disguise these fractures. However, these attempts were in vain, and the fractures are still clearly visible on the lintels today.

**Fig. 8.** Details of the main fractures visible in the lintel above the door, in photographs captured by drone. In addition to the cracks, we can observe remains of materials used in unsuccessful restoration operations (photographs and graphic by the author).

These loads induced the appearance of bending moments in the critical sections (clamped support and center of the span, according to the diagram in Figure 15 below) greater than the cracking moments. Fractures are the visible manifestation of this (Figure 8 and Figure 13).

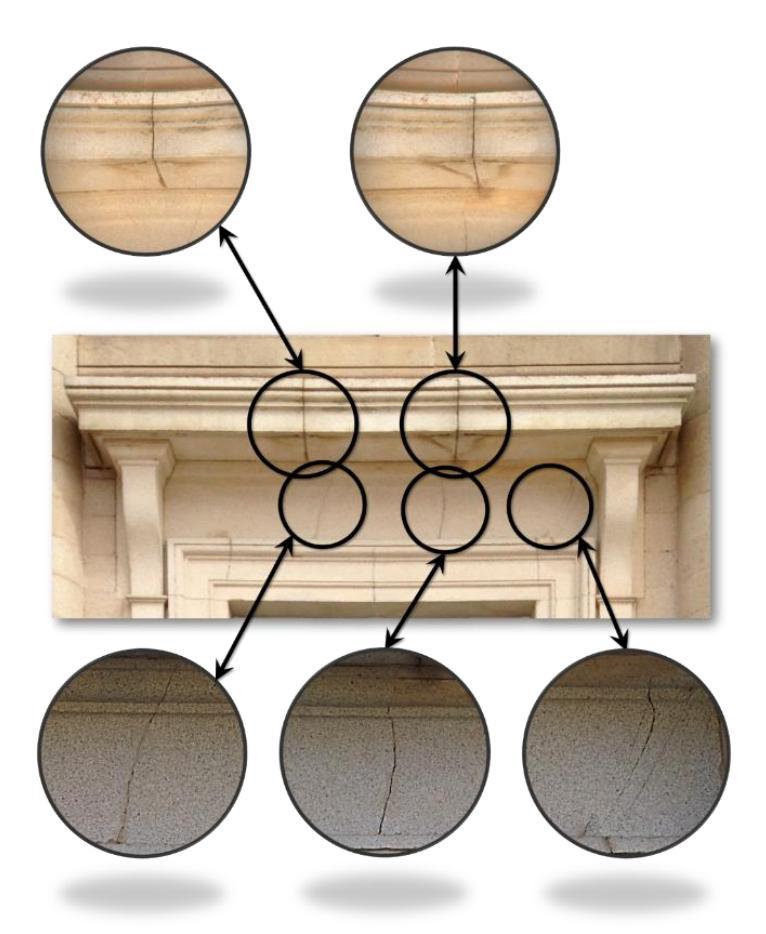
**Fig. 9.** Details of the main fractures visible in the over-lintel, which rests on the element in Fig. 8., in photographs also captured by drone. In addition to the cracks, we can also observe remains of materials used in unsuccessful restoration operations and water marks from runoff on the cornice (photographs and graphic by the author).

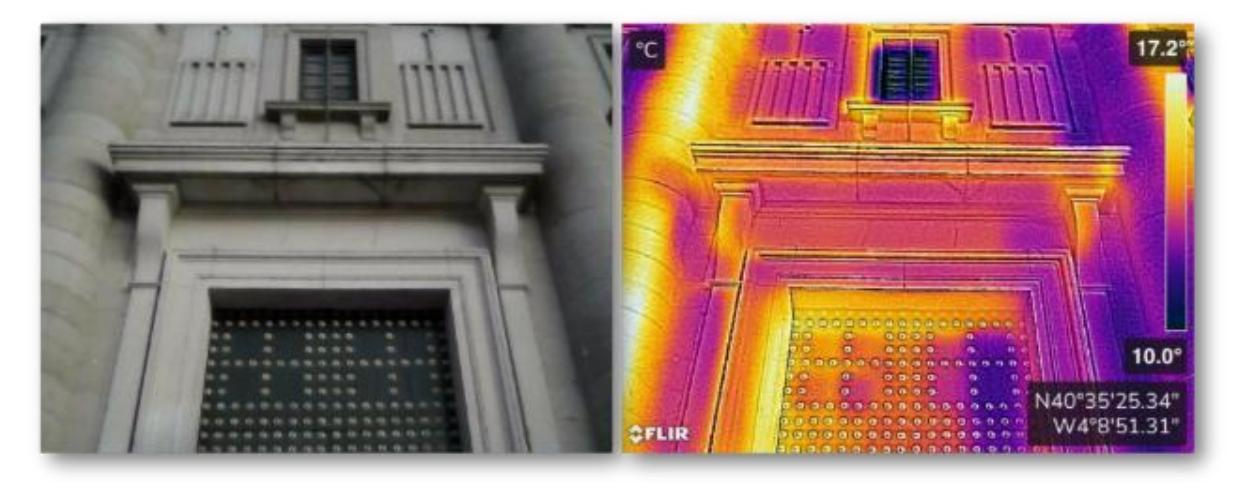
Fig. 10. Photogram (left) and thermogram (right) of the monument area analyzed in this article, in images captured by terrestrial thermography, with a thermographic camera (photographs by the author).

Finally, we must add that the thermographic analysis carried out on the lintel (Figure 10 and Figure 11) corroborated the absence of damage in the different fractures. Not capturing chromatic variations in the thermograms obtained with thermographic cameras (Figure 10 and Figure 11) means that this type of phenomenon is not occurring: there are no deterioration processes related to the presence of humidity (possible frost inside the fractures), related with thermal expansion (or contraction) or related to a possible attack by salts (crypto-efflorescence). Therefore, these fractures do not represent a durability problem for the granite that makes up the lintel.

The analysis carried out concludes that there is no reason to worry about visible cracks from a structural point of view. Similarly, thermography has shown that these cracks do not constitute an entry route for dangerous external agents, so we do not have to be afraid from a durability point of view. Thus, in accordance with the minimum intervention principle, it is not appropriate to carry out any type of intervention on these monolithic stone lintels, although they should be monitored periodically to locate any damage that may occur in the future.

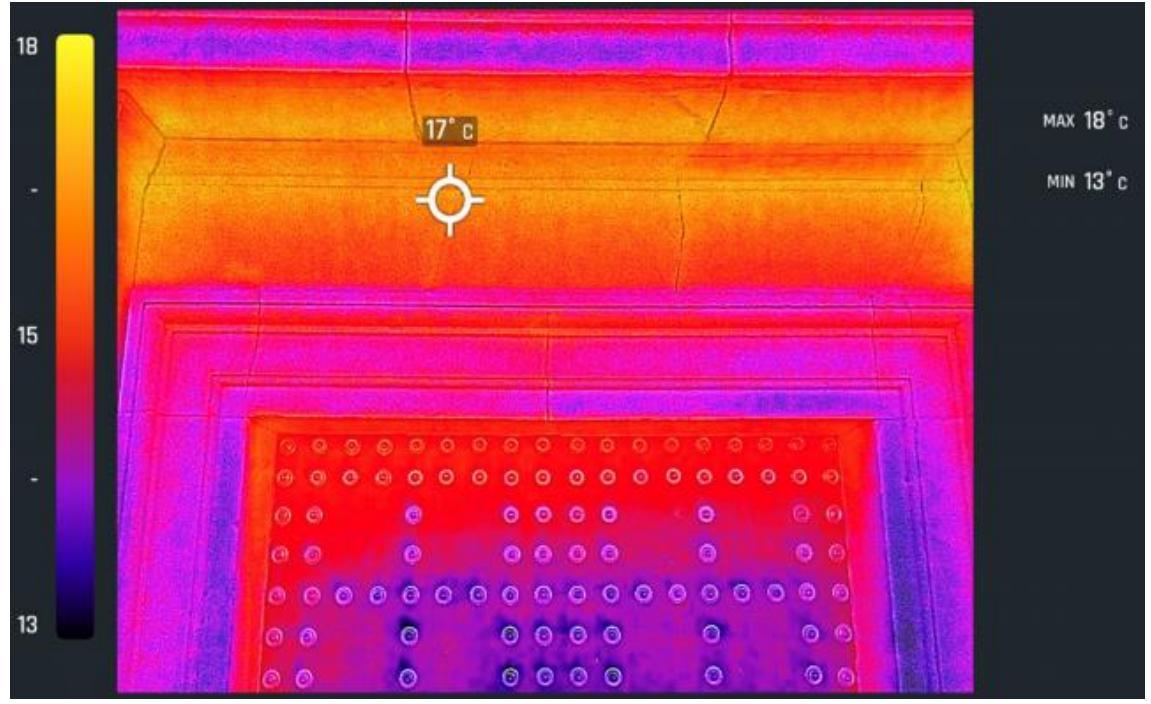
Fig. 11. Thermogram captured by aerial thermography, using the drone seen in Fig. 7, in the lower photograph (photo by the author).

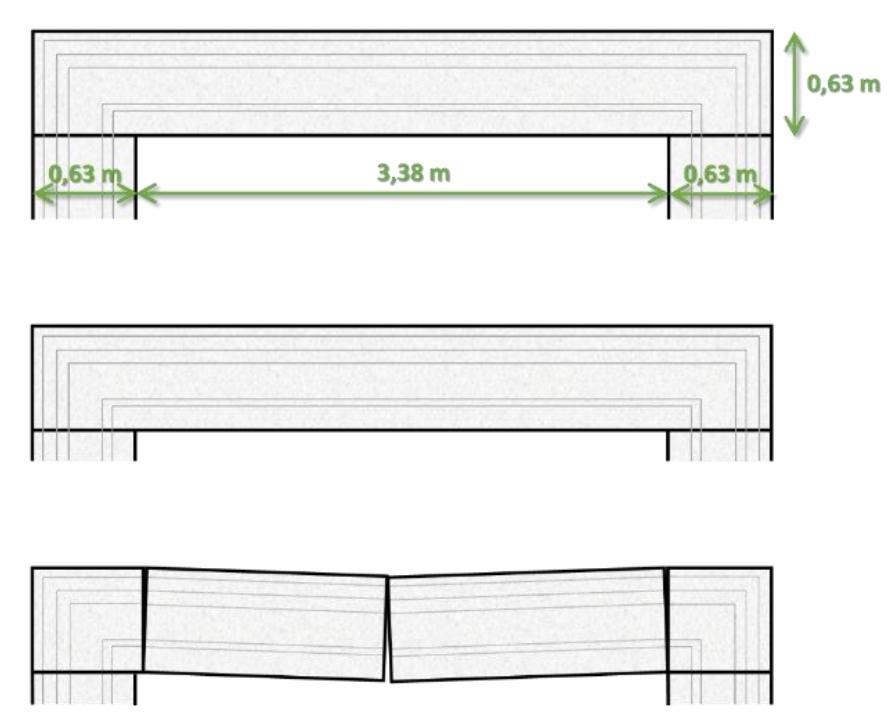
**Fig. 13.** Geometric definition of the first lintel (above), with representation of its ideal state of conservation (center) and exaggerated representation of the fracture processes (below) that we can currently see (graphics by the author).

The lintel and the over-lintel arranged on the main doorway of the Escorial facade are both singlepiece granite elements. The lintel has an open fracture downwards in the center and two fractures upwards on the sides.

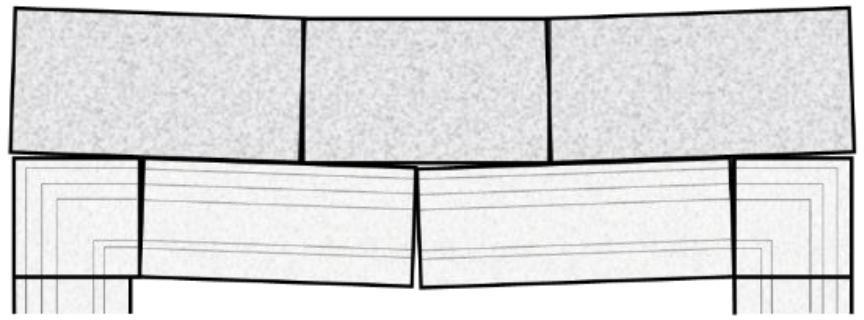
Fig. 14. Exaggerated representation of the fracture processes that we can currently see, including the overlintel (graphics by the author).

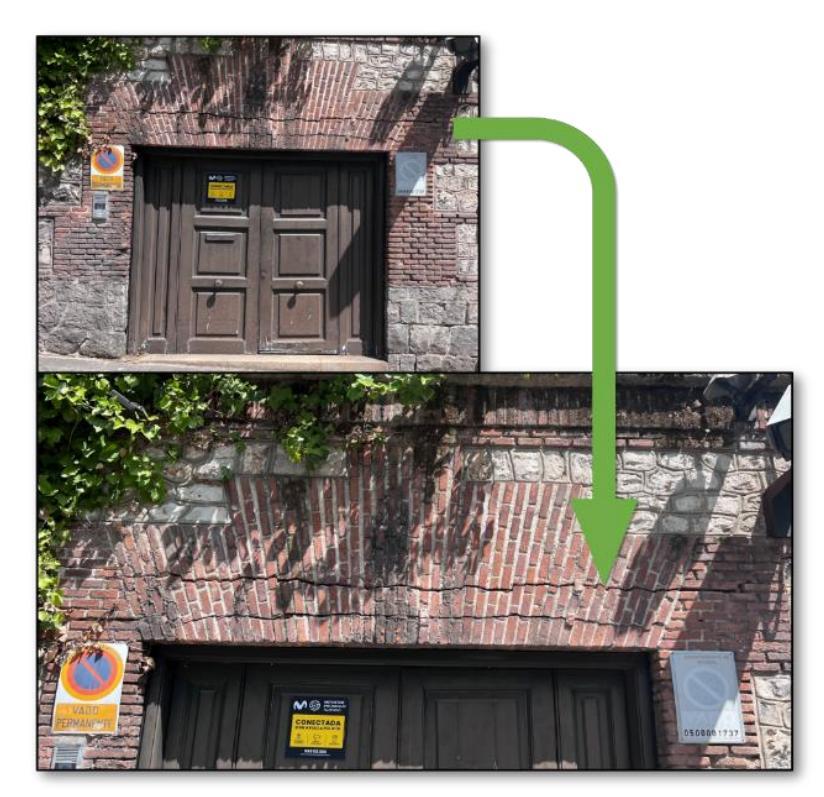
In Figure 17 we can see an example. In this case we have a brick voussoir lintel over the garage door of a residential building located in Madrid (Spain). Heyman's approach that all structures function as an arch is also applicable to voussoir lintels. The fractures that we observe reflect the departure of the geometrical form of the lintel from the anti-funicular curve.

**Fig. 17.** Cracks on a masonry voussoir lintel (a brick plante-bande made of ceramic brick and cement mortar) that show the pressure line now inscribed on the lintel (photographs and graphic by the author).

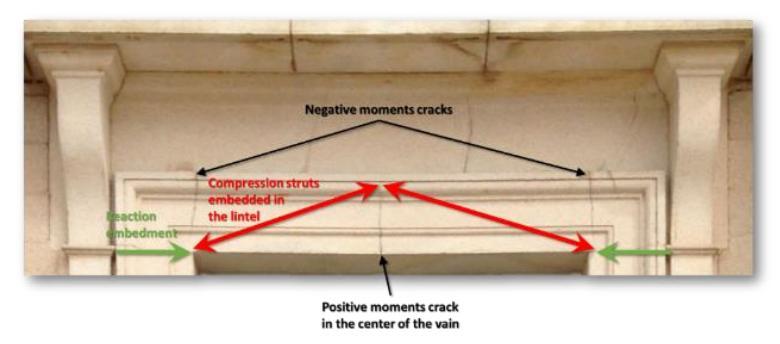
The reaction on the clamped support (green arrow in Figure 18) is a counter reaction. It is essential to ensure the structural equilibrium of the lintel.

Fig. 18. Strut and tie method applied to the lintel analyzed in this article, to justify its current structural equilibrium state (photo and graphic by the author).

This would demonstrate that the lintel experienced a predictable logical and technical reaction. It is a monolithic stone lintel which, before breaking, work in bending as a beam and do not thrust. Indeed, despite being a lintel (linear element, not curved), it ended up becoming an arch. For a structure to collapse or destabilize, it must be able to execute the degree of freedom that determines it. Even if there have been multiple previous breaks that indicate this, if the fractured element cannot move because it lacks this degree of freedom, it will hardly be able to collapse.

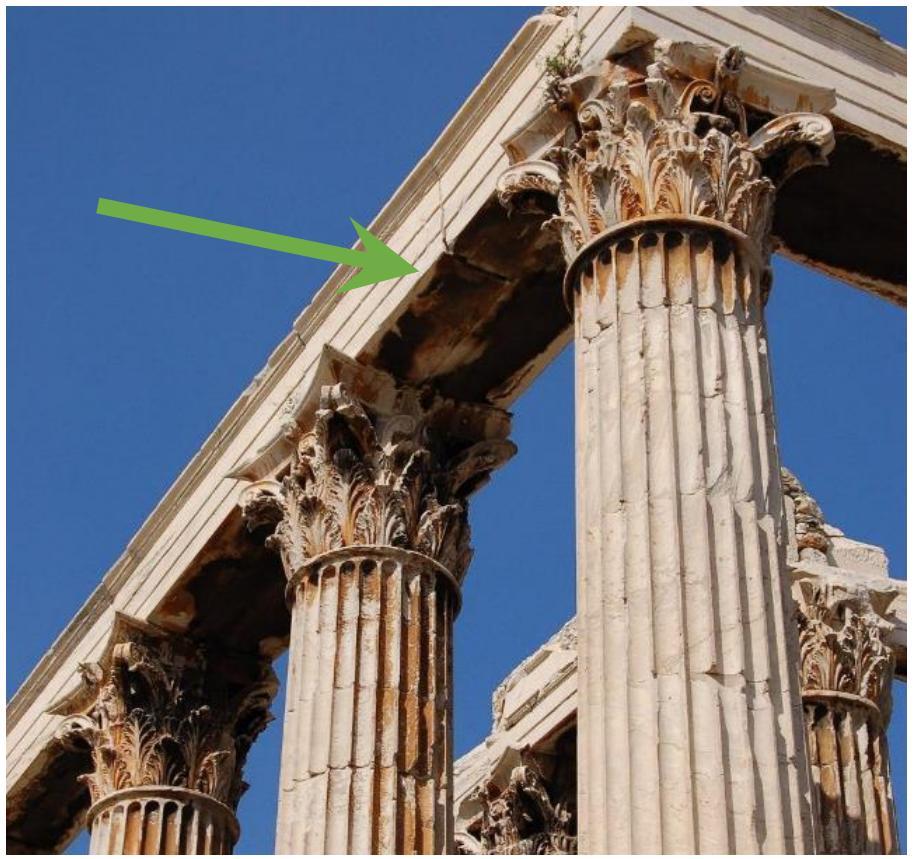
**Fig. 19.** Photograph of the Temple of Olympian Zeus in Athens showing a detail of the Corinthian capitals. The green arrow marks a fracture on the lintel in the center of the span (photo by Wikipedia [29]).

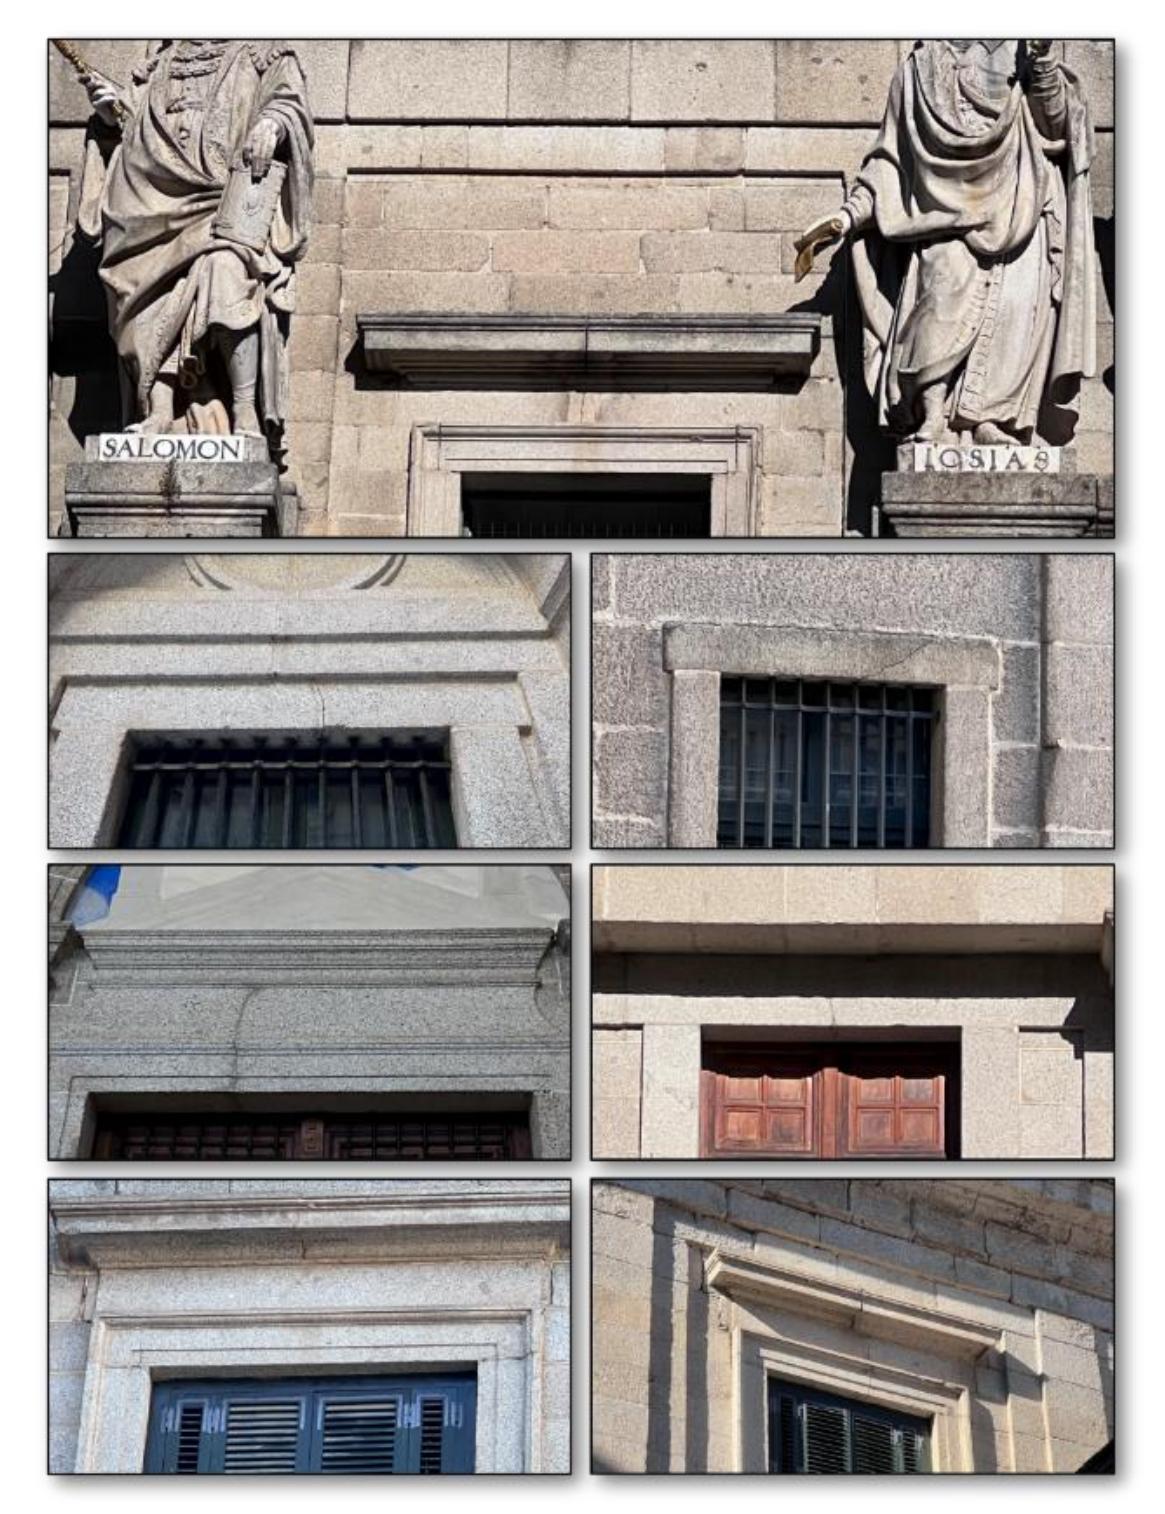
Figure 20 shows various examples of lintels over doors and windows in the Monastery of El Escorial. While they are less representative elements than the lintel that we analyze here, they all demonstrate that the fracture of the entrance lintel was not an anomalous event in the construction of El Escorial.

Fig. 20. Various examples of lintels over doors and windows in the Monastery of El Escorial (photographs by the author).

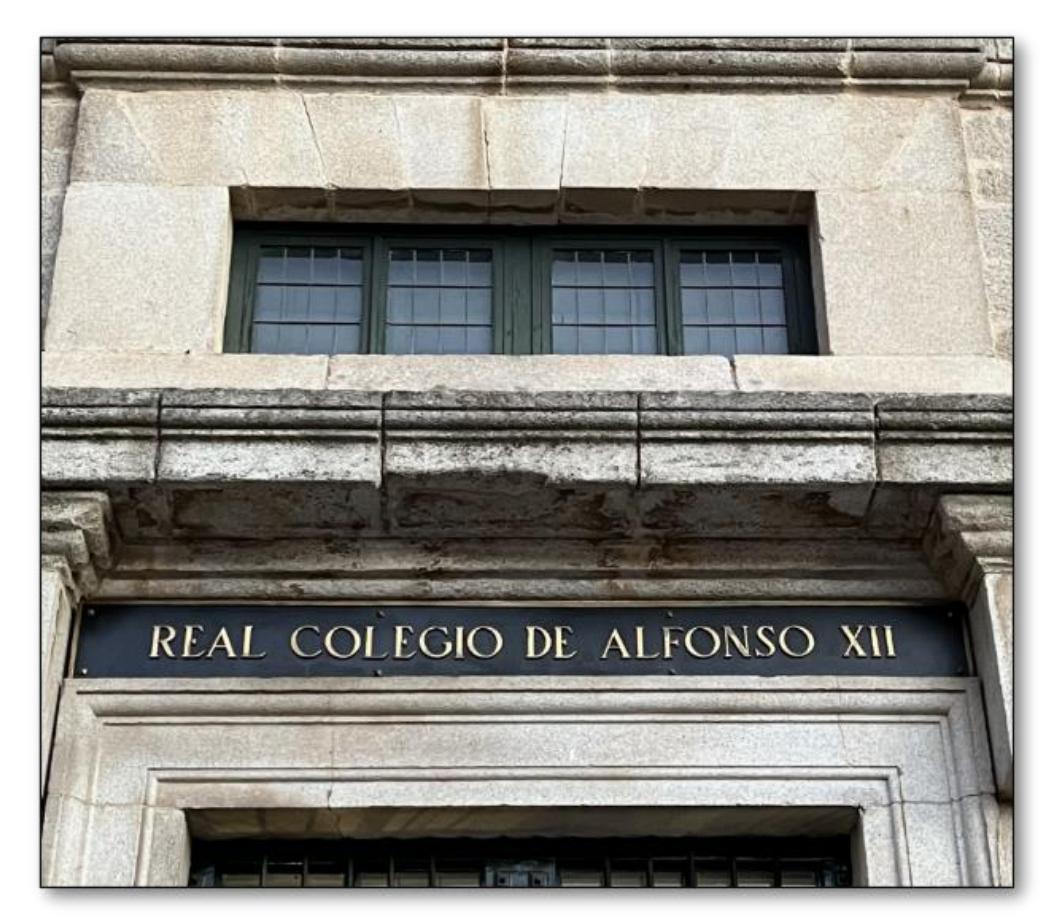
Among all the fractures discovered on the lintels in the Monastery in this investigation, the most interesting was the one we discovered in the lintel of the entrance of the Real Colegio de Alfonso XII (Figure 21), a Catholic school located inside the Monastery and run by the friars. The entrance to the school is also located on the west facade of the Monastery (room 63 of the plan in Figure 4). This means that this lintel is located on the same facade as the main door lintel. If we look at Castello's drawing (Figure 12), we can see that this part of the facade was made before the central part of the facade, where the lintel that we analyze in this article was located.

**Fig. 21.** Lintel over the main door of the Real Colegio de Alfonso XII, also located on the west facade of the Monastery of El Escorial, incorporating a voussoir lintel over the upper window (photo by the author).

Here we can see another difference with respect to the main door of the Monastery. There is a window above the lintel of the school door. The span of this window is formed by a fitted plate-band lintel with granite voussoirs. We must not forget that Heyman also considered voussoir lintels in his analysis, since according to him they also end up functioning as an arch [24]. In this case, structural equilibrium is also possible if we have abutments capable of causing the required horizontal reaction. If we analyze the upper lintel (Figure 21), we can observe the lack of alignment of the voussoirs, this being especially noticeable in the central voussoir. The phenomenon has been the same: the voussoirs have moved until they reached a stable position for an imperfectly fitted plate-band [24]. In other words, since it is not a monolithic lintel, the voussoirs do not break. Before a voussoir fractures, the complete lintel produces a hinge and seeks stability through the formation of a pair of articulated struts.
