Journal of Rehabilitation in Civil Engineering

Biaxial Loading Capacity of H-Type Reinforced Concrete Electric Poles

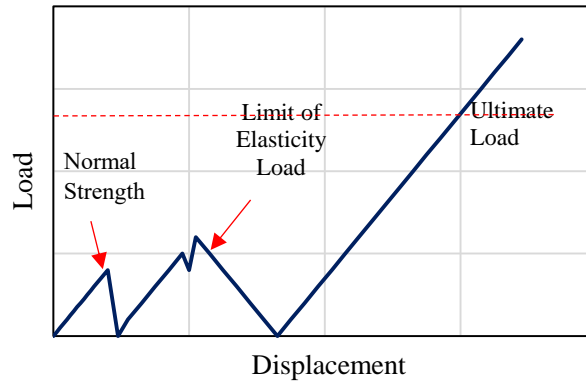
Fig. 5. Schematic illustration of the loading protocol proposed in the Iranian Standard for H-type Utility Poles.

The tests were carried out under either of two loading regimes. The first one was proposed by the Iranian Standard for H-type Utility Poles [15] as shown in Fig. 5 while the second loading regime was a monotonically

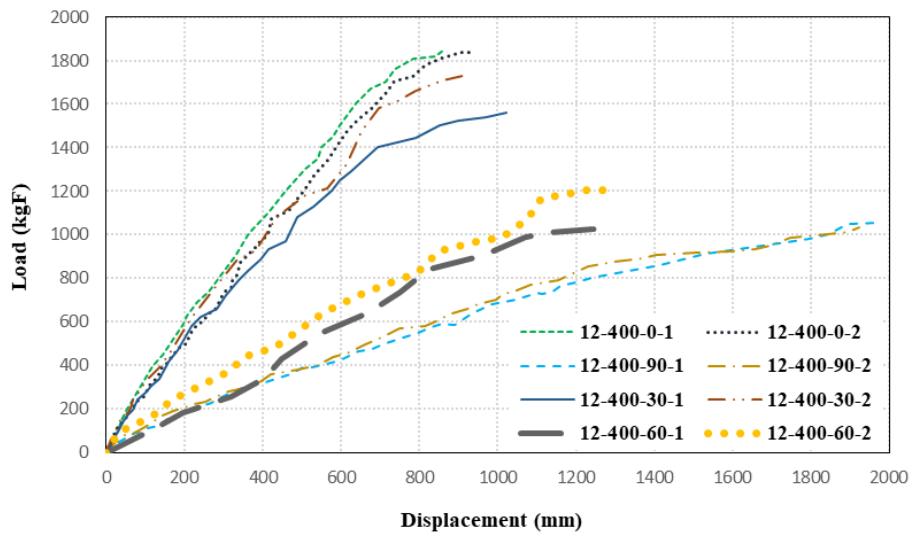
Fig. 8. Load-deflection curves of a) 9-400 and b) 12-400 specimens.**Table 6.** Summary of the test results and failure modes of the 12-400 poles.

Except for the poles loaded at zero degree, all the others were tested under the first loading regime (i.e. monotonically increasing the load) up to failure. Fig. 8 compares the load-displacement curves for all the tested poles at different angles. Based on the obtained results, the load-displacement behavior of the poles loaded at 60° is close to those bent about their minor principal axes (90°) while those loaded at 30° are similar to those bent about their major principal axes (zero degree).

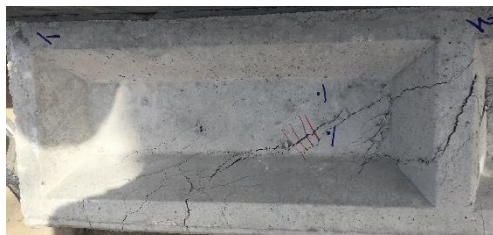
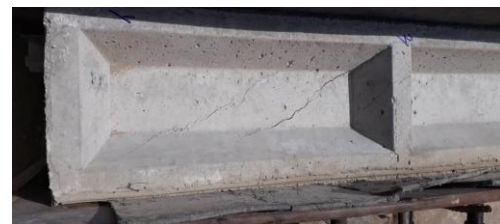
Fig. 9. Diagonal shear cracking of: a) 9-400-0-1, and b) 9-400-0-2.

monotonically increasing load (loading regime 2). The first noticeable cracks in 9-400-0-1 were observed at the second step restricted within the base at a load of 401 kgF corresponding to a displacement of 84 mm. In 9-400-0-2, cracks initiated at the same place and similar load corresponding to a displacement of 77 mm. As loading proceeded, flexural cracks propagated along the length of the poles. Subsequently, diagonal shear cracks also appeared in the first two steps of the poles at the support leading to ultimate failure as shown in Fig. 9. The maximum recorded loading capacities were 1601 and 1780 kgF for 9-400-0-1 and 9-400-02, respectively.

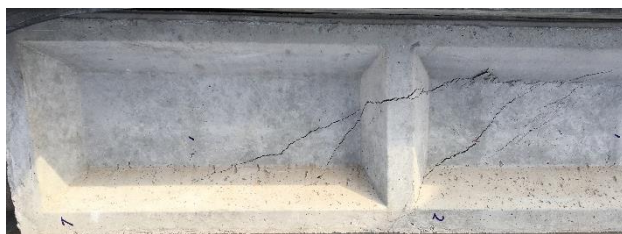
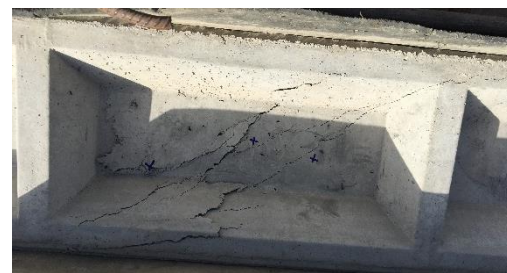
Fig. 10. Shear cracks in: a) 12-400-0-1, and b) 12-400-0-2.

The first visible cracks in 12-400-0-1 and 12-400-0-2 developed at the first two steps within the base and at loads of 397 and 393 kgF corresponding to displacements of 117 and

144 mm, respectively. With the load increment, diagonal cracks expanded at the support leading to the ultimate failure at loads of 1850 kgF for 12-400-0-1 and 1836 kgF for 12-400-0-2. Fig. 10 shows the shear cracks and failure status in both 12-400-0-1 and 12-400-0-2. The formation of shear cracks inside the support may be attributed to the high shear force arising from the three concentrated reactions. Such behavior can hardly ever happen in real field conditions due to the continuous support provided by the surrounding concrete foundation and the soil. Consequently, it is estimated that the loading capacity of poles in real field conditions might be higher than that achieved through the implemented setup which is proposed by the Iranian Standard for H-type Utility Poles [15].

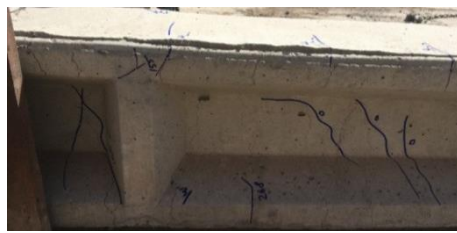
Fig. 15. Cracking patterns in: a) 9-400-90-1, and b) 9-400-90-2.

formation of flexural cracks at loads of around 155 kgF followed by flexural cracks spreading along the poles as shown in Fig. 15. At loads of 405 and 301 kgF, flexural cracks propagated towards the web in 9-400-90-1 and 9-400-90-2, respectively. Eventually, the poles failed at loads of 1204 kgF for 9-400-90-1 and 1062 kgF for 9-400-90-2.

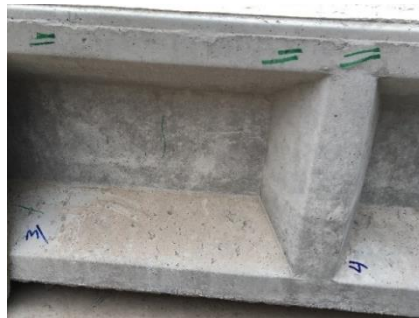
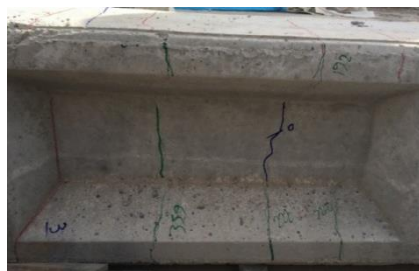
Fig. 16. Cracking patterns in: a) 12-400-90-1, and b) 12-400-90-2.

respectively. As loading proceeded, the flexural behavior became more dominant. Finally, 12-400-90-1 and 12-400-90-2 failed at loads of 1056 and 1033 kgF, respectively. Fig. 16 shows the cracking patterns in these specimens.

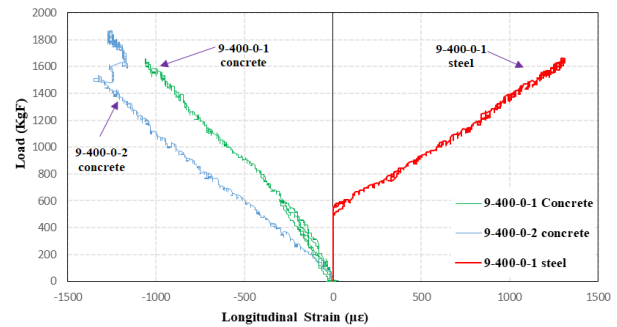
Fig. 17. Strain variations in steel rebars and concrete in 9-400-0-1 and 9-400-0-2.

Fig. 17 presents the strain variations in both the tensile reinforcement and compression concrete measured by the strain gauges installed about 300 mm away from the support towards the pole tip.

It should be noted that the strain gauge installed on steel reinforcement in 9-400-0-2 failed during the fabrication and casting. The fluctuations in strain values versus the applied load were almost linear up to failure in both the steel rebars and concrete. The maximum tensile strain in steel rebars was $1300 \mu\epsilon$ in 9-400-0-1, which is much lower than the yield strain (around $2000 \mu\epsilon$). Furthermore, maximum strain values in the compressive concrete in 9-400-0-1 and 9-400-0-2 varied between 1000 and $1400 \mu\epsilon$, which are lower than the strain corresponding to the maximum compressive strength of concrete (i.e., around $2000 \mu\epsilon$).
