Journal of Rehabilitation in Civil Engineering

An Outcome Overview of Housing Rehabilitation and Reconstruction in Mataram City Post Lombok Earthquake Disaster

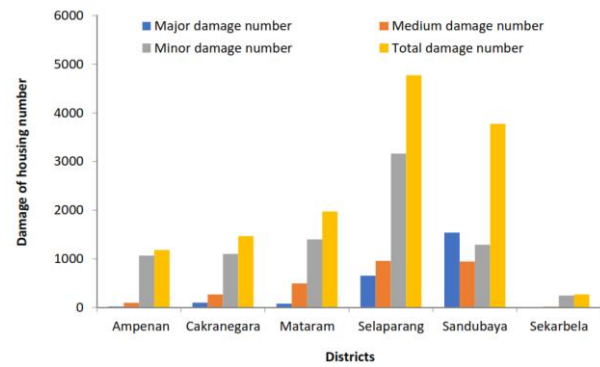
Fig. 2. Distribution of house damage in Mataram City in each district.

According to Fig. 2, Selaparang District has the highest total number of house damage, consisting of many medium and minor damage. However, Sandubaya District experienced the highest number of major damaged houses. Therefore, this area was intended for field visits during the rebuilding of houses.

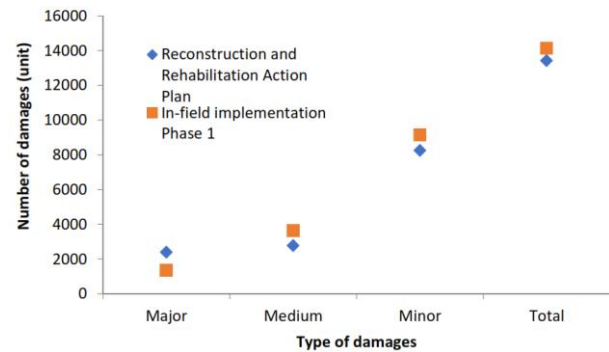
Fig. 3. Comparison number of damages between reconstruction and rehabilitation action plan and in-site data.

The comparison of the number of damaged houses from the Reconstruction and Rehabilitation Action Plan data and in-field implementation data can be seen in Fig. 3. Compared to the initial data in the Reconstruction and Rehabilitation Action Plan, from a total of 14140 damaged houses that received assistance, the number of major damages decreased by 43.66% to 1350 houses. However, the number of medium and minor damaged houses increased to 30.75% and 10.83%, respectively, to 3631 and 9159 houses. The increase in the number of medium and minor damaged houses was because, after

the seismic assessment of housing, some aftershocks continued to occur even with a magnitude more powerful than the previous earthquake; therefore, the condition of damaged houses increased.

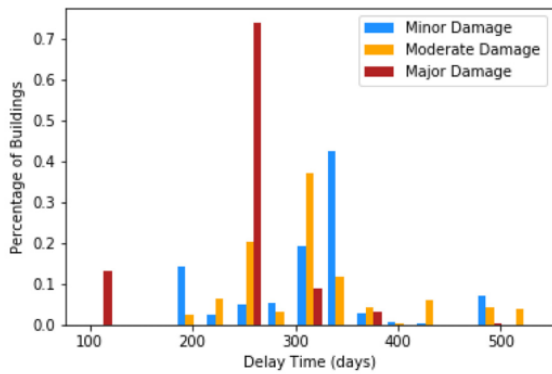
Fig. 6. Histogram of the delay construction time calculation in Mataram City [25].

The delay time in the reconstruction process in Mataram has been studied using a time-based stochastic model and is shown in Fig. 6 [25]. The delay time is the time of a building to obtain a reconstruction crew and the materials needed to reconstruct. The data used in the calculations was up to March 2020. The delay time for the reconstruction of buildings with major damage was recorded for almost one year, and the largest number of major damaged buildings experienced a delay time of around 8-9 months.

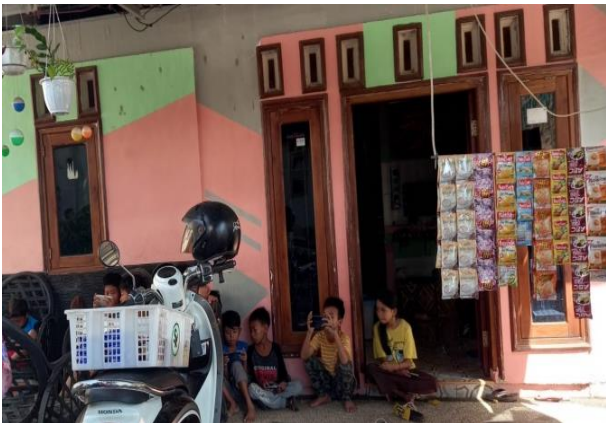
Fig. 7. Front View of Built House.

house area was 17.5 m². Visually, the houses are fixed vertically and firmly, and the materials used follow RISHA specifications. The houses are fully structurally constructed, starting from the foundation, foundation beams, columns, beams, and roof. In receiving housing construction assistance worth 50 million IDR, the costs for constructing ceramic floors and ceilings could not be covered for the house with an area of 36 m². However, some residents independently provided ceramic floors and ceilings for their houses. However, for the house with a smaller area, the construction assistance funds can be included ceramics floors and ceilings.

During the construction of the houses, electricity facilities, wells for the water source, drainage, and communal toilets for 3-4 houses were also provided. Fig. 7 illustrates a house built using the aid.

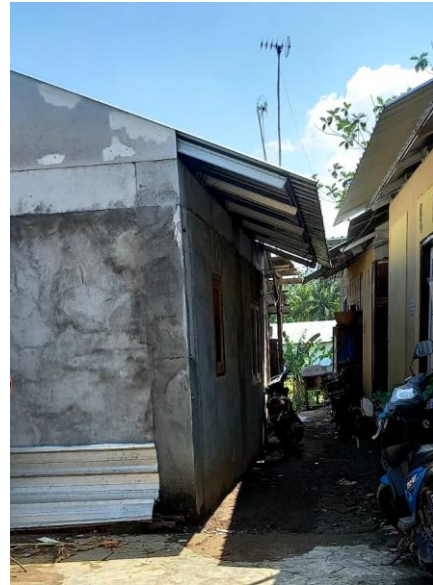
Fig. 8. Expanded Distance between Two Houses.

In addition, compared to conditions before the reconstruction, wider side alleys are currently available. During the housing construction, each housing area was reduced by 20 cm from each side to enlarge the side alleys to make disaster evacuation easier in the future. Fig. 8 shows the expanded distance between the houses.

Furthermore, residential houses have been built in the previous area in accordance with the legal certificate they have. The housing was not relocated, and the city did not move after the reconstruction process. The only thing that has changed is the type of houses built to be more earthquake resistant and the distance between houses extended to provide the evacuation route.
