## A review on Advanced strengthening techniques for corrosion-damaged Reinforced Concrete structures

Mankare Ulka Shesharao <sup>1</sup>; Viswanathan T.S <sup>2,\*</sup>

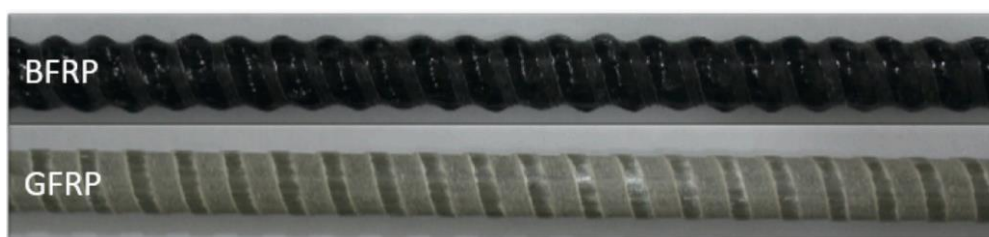
**Fig. 1.** NSM–BFRP and NSM–GFRP bars were employed to reinforce and improve the structural integrity of the slabs. Adapted from Aljidda et al., (2023) [14].

Near Surface Mounted-Basalt Fibre Reinforced Polymer (NSM-BFRP) and Near Surface Mounted-Glass Fibre Reinforced Polymer (NSM-GFRP) bars The bars utilized in this research study are shown in Fig1.

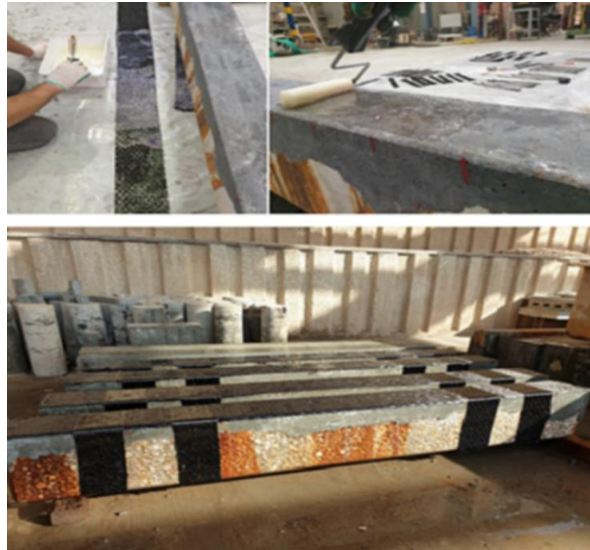
**Fig. 4.** Process for applying CFRP. Adapted from Kharmar et al. (2022) [27].

The CFRP laminates were cleaned with a high-pressure air jet to get rid of dust and other tiny particles before being affixed to the beam surfaces. For a stronger bond, the U-shaped CFRP laminates' edges were rounded using a grinder. To provide adequate anchorage and lower the chance of failure from debonding, these laminates were wrapped around particular sections of the beams [34,37,38]. The CFRP laminates applied to the beam surface, wrapped in U-shaped CFRP laminates, are depicted in Fig. 3. As directed by the manufacturer, the epoxy resin and hardener were combined [39]. The fibers were thoroughly soaked in the epoxy using a specialized paint roller. Following this, the CFRP laminates were affixed to the surfaces of the beams. For seven days, the beams were allowed to cure at an average temperature of 36°C. The procedures for attaching CFRP laminates to the corroded beam specimens are depicted in Fig. 4.

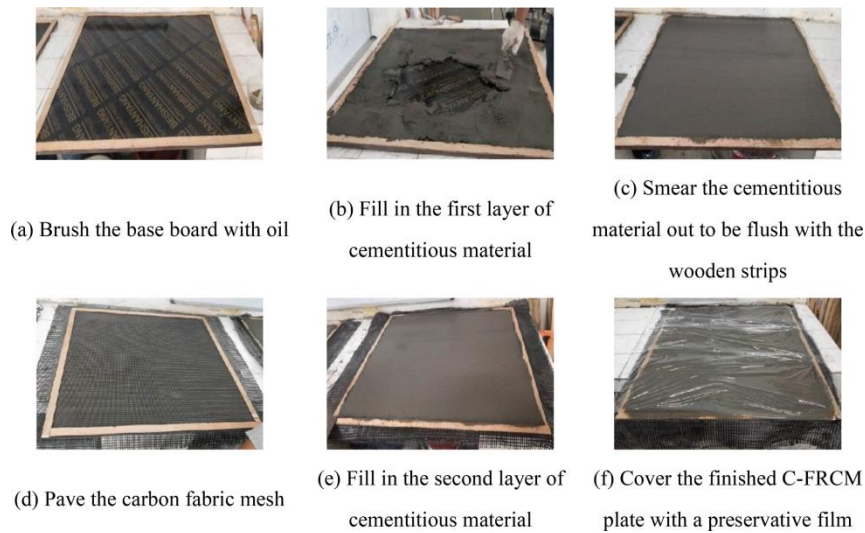
**Fig. 6.** Process of prefabricated C-FRCM plate. Reproduced with permission from Feng et al. (2022) [23].

Rather of being cast in place as is customary, the C-FRCM material utilized in this investigation was supplied as a prefabricated plate. This was done to expedite the strengthening process and facilitate the direct bonding of the C-FRCM plate to the surface of the beam. The plate was intended to have two layers of cementitious matrix and one layer of carbon fiber mesh, with a thickness of 6 mm. The creation of the Cementitious Fiber Reinforced Composite Material (C-FRCM) plate is depicted in Fig. 6. The steps are as follows: First, a thick foundation plate was fixed with 3 mm thick wooden strips to produce a mold. To keep its surface clean and facilitate the eventual removal of the C-FRCM plate, the base plate was oiled. The base plate was then covered with the cementitious matrix. The mesh of carbon cloth was cut and placed over the matrix. The cementitious matrix was smoothed out to match the surrounding wooden strips, and another set of 3 mm wooden strips was placed on top. To make a multi-layer Cementitious Fiber Reinforced Composite Material (C-FRCM) plate, same procedure was repeated. Following creation, the plate was placed in a shaded area to solidify and covered with a protective coating. After the plate had hardened, the film and mold were taken off, and it was left in a regular curing room for 28 days. The entire C-FRCM plate manufacturing process is depicted in Fig. 10. A polarization device was built up to mimic the C-FRCM plate acting as the anode in the ICCP system (Fig. 7). The plate C-FRCM was To prevent the C-FRCM plate from coming into contact with the stainless steel cathode, it was encased inside an organic glass container and supported by tiny wooden blocks. A saturated calcium hydroxide and 2% sodium chloride solution was put into the container. The positive and negative poles of a power source were linked to the stainless steel plate and the C-FRCM plate, respectively. The potential of the C-FRCM plate was periodically measured throughout the test using a reference electrode.
