Journal of Rehabilitation in Civil Engineering

# Historical and Structural Analysis of the Lintel Fracture Over the Monastery of El Escorial Main Door

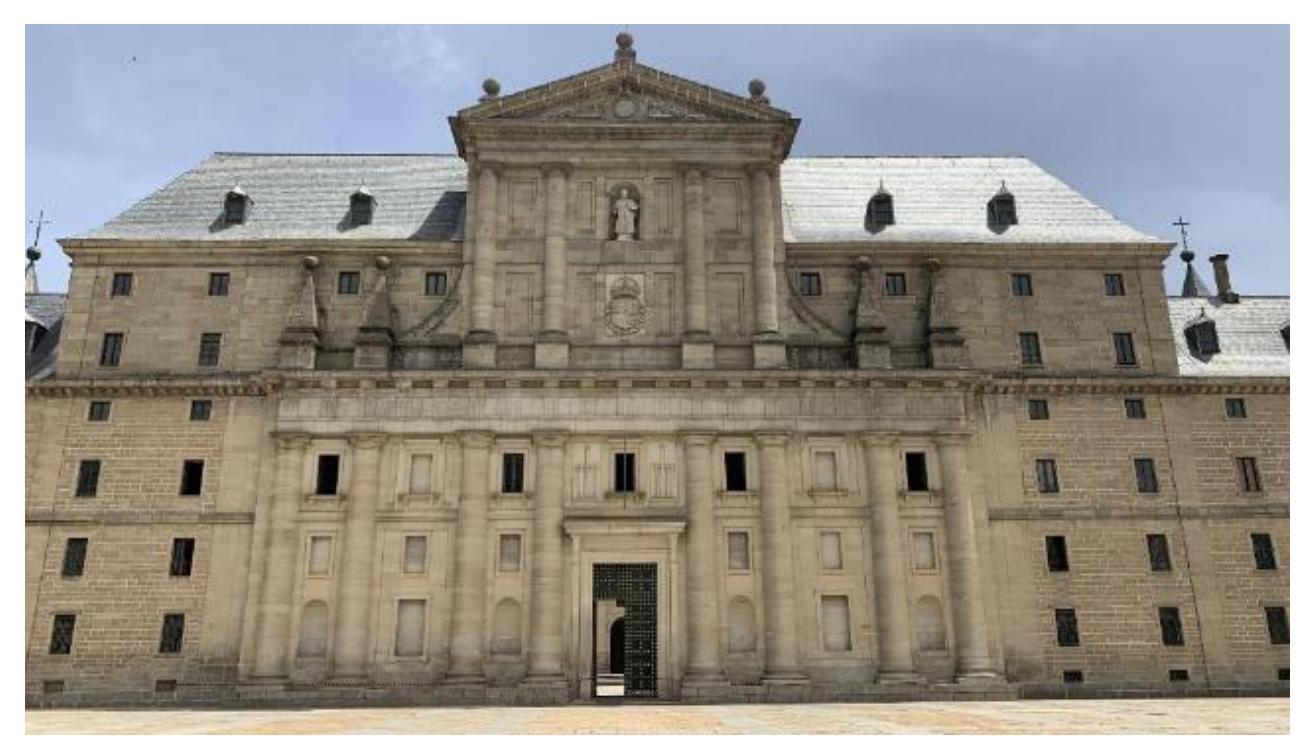
Fig. 2. Primary entrance to the Monastery of El Escorial, located on its western facade (photograph by the author).

This single-span entrance is possible thanks to two one-piece lintels, arranged one above the other, with a small cornice above them (Fig. 3). We do not need to get very close to notice striking fractures in these two elements. Here we are going to try to explain these fractures and assess whether they present any cause for concern.

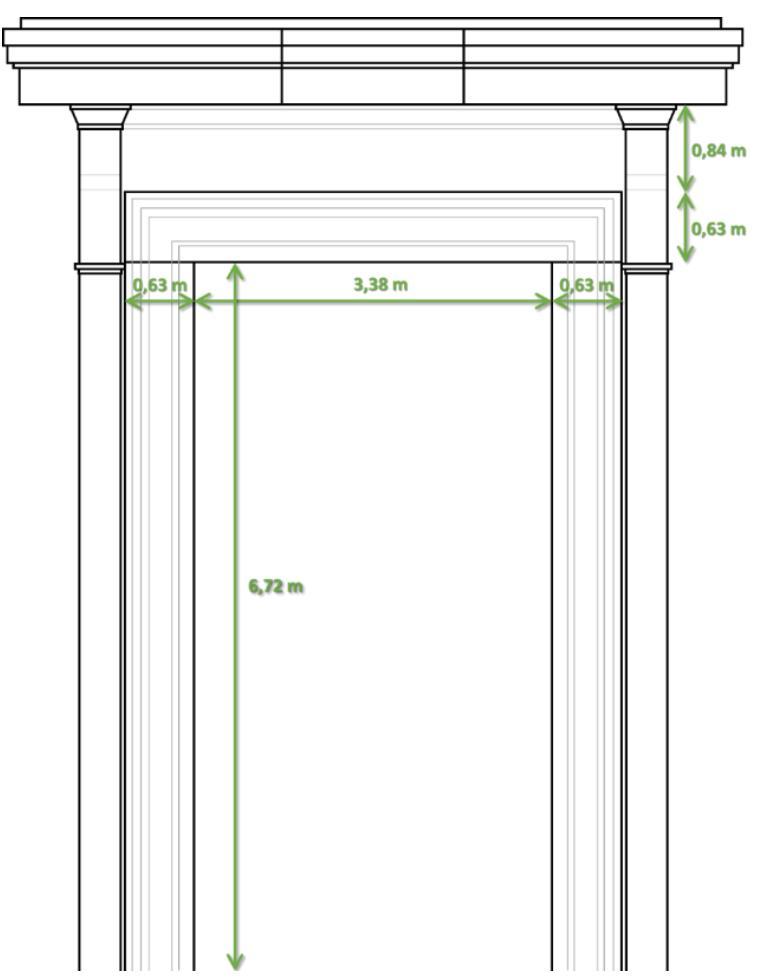
**Fig. 5.** Geometric definition of the entrance door on which the lintel analyzed in this article is located (graphic by the author).

To carry out this work, the first thing we did was a complete geometric characterization of the door (Fig. 5) using a tape measure and a laser measure [5]. With them, we determined the dimensions of the single-span entrance (3.38 m x 6.72 m), the first lintel, and the lateral stone supports.

- Measured column width (Fig. 5) = 0.63 m.
- Span according to Vitruvius =  $3 \times 0.63 \text{ m} = 1.89 \text{ m}$ .
- Measured span = 3.38 m, which is 50% more than the span postulated by Vitruvius.

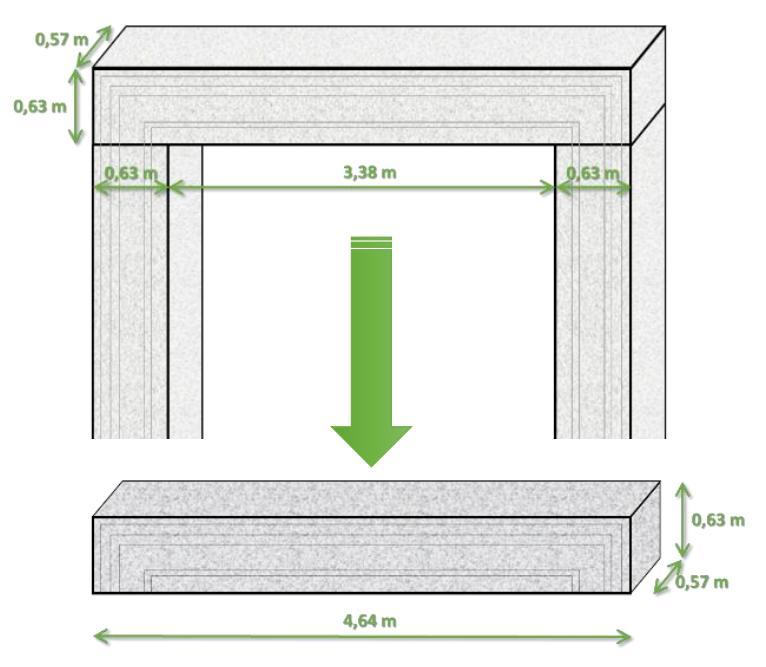
**Fig. 6.** Three-dimensional representation of the monolithic stone lintel and its two supports (above) and representation of the isolated monolithic stone lintel (below) with its dimensions (graphics by the author).

To obtain a better geometric definition and estimate its structural behavior, a three-dimensional representation of the lintel was also made (Fig. 6). The geometric measurement also allowed us to quantify the deflection in the middle of the monolithic stone lintel, which was 6 mm.

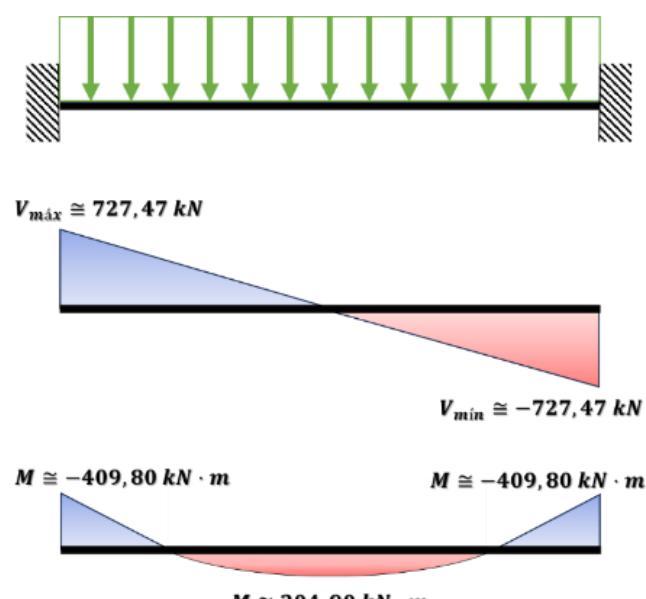
Fig. 15. Synthesized representation of the uniformly distributed load that acts on the double-recessed lintel beam (upper diagram), resulting shear force (middle diagram) and moment (lower diagram) (diagrams by the author).

To estimate the overlying load, the average height of the facade above the lintel and over-lintel has been taken into account: 27 m. Obviously, this approach entails three considerable errors that we cannot ignore:

- 1. The height of the facade is not constant nor is it uniform: for example, there is a gabled facade. For this first approximation, the average height in the studied facade area has been considered.
- 2. The thickness of the facade is neither constant nor uniform. For this first approximation, a thickness similar to the thickness of the lintel has been considered.
- 3. Facade openings have not been discounted nor have facade irregularities been considered for calculation purposes. For example, above the entrance door there is a window.

$M \cong 204, 90 \ kN \cdot m$

These three reasons show that the uniformly distributed load represented in Figure 13 is not correct: it does not correspond to reality, because the load supported by the lintel is not uniform. Therefore, we cannot assume the resulting values.

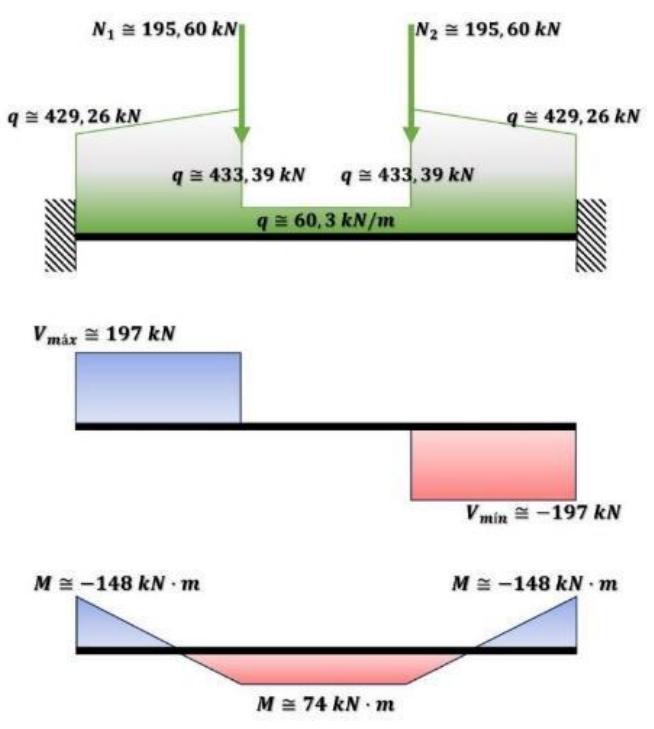
Fig. 16. Synthesized representation of the real load distribution that acts on the double-recessed lintel beam (upper diagram), resulting shear force (middle diagram) and moment (lower diagram) (diagrams by the author).

Therefore, initially we could not accept such values. However, the complete analysis of the data, omitting the three previous conditions, would give us a stress diagram similar to that in Figure 16, with the resulting shear force and moment. Note that the values obtained do not differ significantly from the previous ones.

However, we cannot validate this hypothesis. The consideration of the embedment before rupture is correct, but to the extent that its moment is double at its ends than in the middle of the span of the structural lintel. The design simulation in (Figure 15 and Figure 16) has nothing to do with the actual structural reality defined Figure 13. The limit analysis referred to in this article must be performed on Figure 13 and the joints created therein. Since the stress diagrams do not clarify this process, we must justify how the process of its rupture and the current stability process was carried out.
