# Mechanics of Advanced Composite Structures

## Experimental Investigation of Repair of Glass Epoxy Composite with Edge and Center Crack by Epoxy Resin

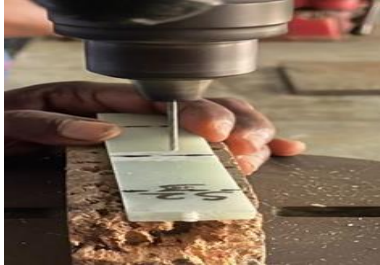
Fig. 1. Specimen drilled for Repair work.

Drilling of failed glass/epoxy composite materials follows a similar process as drilling in other materials. To begin, prepare the specimen for drilling and secure the composite material securely, as shown in Fig. 1. A carbide drill bit is chosen to perform the drill as per the hole diameter. Mark the drilling location using a

marker or punch, and then cutting fluid is applied to reduce the heat produced during the drilling process. Constant speed is maintained to avoid overheating of the composite material and continued drilling up to half depth. After drilling, the hole was inspected for delamination and splintering, and sandpaper to smooth the edges.

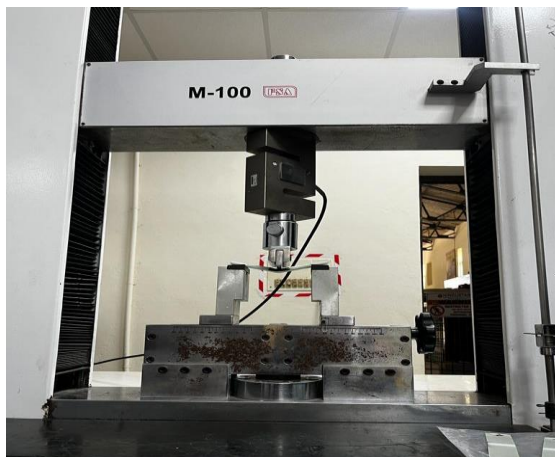
Fig. 2. Specimen mounted in UTM.

The fabricated glass epoxy composite is cut into specimens in accordance with the ASTM standards D390, respectively, as shown in Fig 2. This is done in order to assess the flexural properties of the material and its repair strength after the repair work. A three-point bending test is conducted at the Hindustan Institute of Technology and Science, Department of Aeronautical Engineering, using a 100N universal testing machine. The specimen is marked for the support point and midpoint for easy positioning of the supports in the 3-point bending fixture. The specimen is placed in the lower fixture as per the marking, and the upper fixture is moved to the midpoint of the specimen, after it touches the specimen, the position is fixed. The gauge length, span, and thickness of the specimens are measured before the conduct of the test. The experiment was performed in a UTM using a machine that had a capacity of 100 kN at a stroke rate of 1 mm/min. All data from the experiment were recorded so that they could be analyzed later.

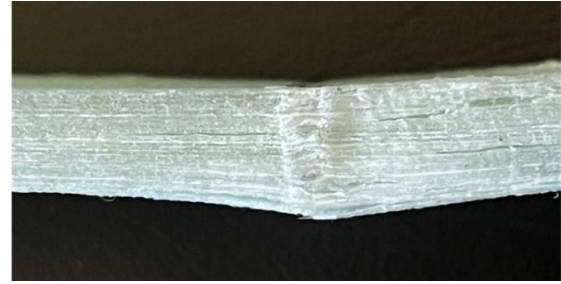
Fig. 3. Delamination of glass fiber laminate after 3-3PBT

The flexural test curve of a glass/epoxy composite material provides its mechanical properties and performance under bending loads. The curve begins with an initial linear elastic region. In this region, the material behaves elastically and follows Hooke's law. As the load increases, the material reaches its proportional limit and forms a plastic region. The ultimate load or stress is the peak where the material reaches its maximum load or stress, where significant deformation may occur but not yet fail. The post-peak region transitions to a post-peak region where the material continues to deform and the load or stress decreases. The failure point signifies the ultimate flexural strength. Damage depicted in Fig. 3.

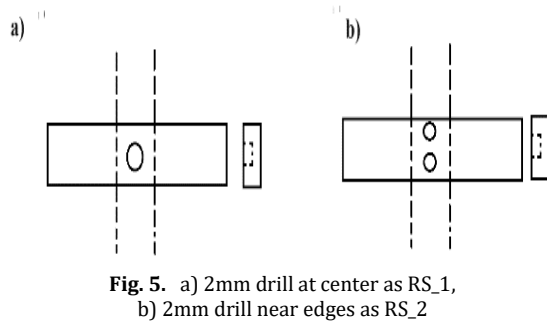
The tested samples are prepared for repair using the drilling method. The failed samples are taken for a hole. Partial drilling is employed, one set with one hole and the other set with two holes with a 2 mm depth, as represented in Fig 5.

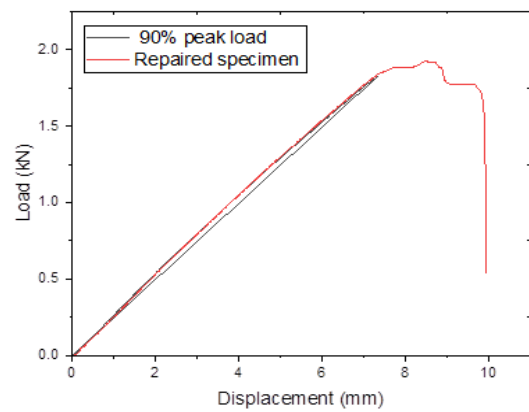
Fig. 8. Comparison of Replaced specimen at 90% peak load with Neat Glass/Epoxy specimen

The graph represented in Figures 8, 9 shows the results of a repaired 90% peak load specimen and a 60% peak load specimen. The curves are in line with the base sample, which shows the optimized repair work. After that, it attains a new peak load and the load drops. This increase, however, is due to the strength of the repair work.
